**DEPARTMENT OF TRANSPORTATION**

Quality Assurance and Source Inspection

## WELDING INSPECTION REPORT

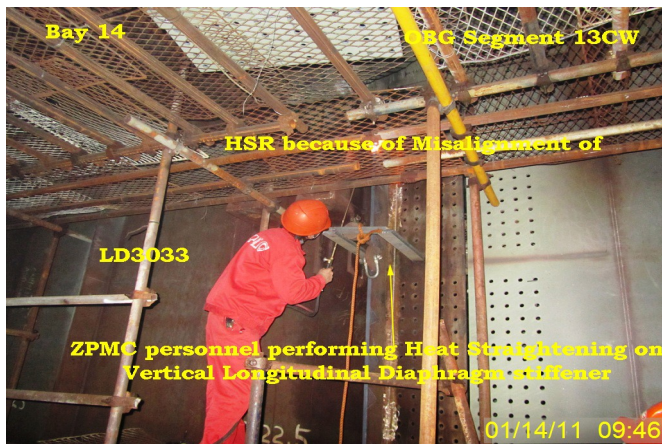
ZPMC personnel performing heat straightening on Longitudinal Diaphragm Stiffener of OBG Segment 13CW member identified as LD3033. Distortion appeared to be caused by misalignment stiffener of the welding/material. ZPMC Quality Control (QC) inspector identified as Mr. Li Ming Yang was present to monitor the heat straightening process. The heat straightening appeared to comply with HSR1 (B) number 10075. See the attached picture.
